## SECTION C

# THE IGNITION SYSTEM

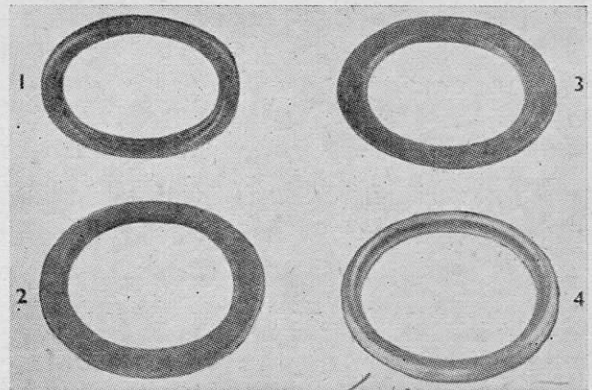
FIG. 17.—This illustration shows plug gaskets in various conditions. (1) Indicating insufficient tightening down on the plug. (2) Over-tightening of the plug. (3) Correct degree of tightening. (4) New gasket before use.

Gaskets in different conditions are illustrated in Fig. 17. The upper left-hand gasket was obviously not properly compressed, owing to the plug not being tightened down sufficiently.

The lower left-hand gasket clearly indicates that the plug was pulled down too tightly or has been in service too long. Note its distorted condition and the evidence of blow-by, which is a prolific cause of plug overheating.

The right-hand upper gasket is in good condition, providing an adequate seal and a good path for heat dissipation.

For comparison a new gasket is shown in the lower right-hand corner of Fig. 17.
